# PLAY AREA SAFETY INSPECTION REPORT

Winterbourne Stoke Parish Council

15 September 2017

Site Owner : **Winterbourne Stoke Parish Council**  
Site Name : Winterbourne Stoke PC - St. Peters Close  
Date of Inspection : 15 September 2017  
Inspected by : Peter Mann

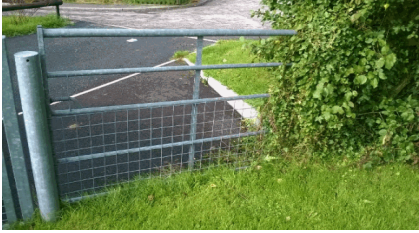
<p>Gate - Maintenance</p> <p>Risk Score : 4 Risk Level : Low</p>	<p>Entrance</p>	<p>Finding : Gate - Maintenance - Not Locked</p>

<p>Task : Lock maintenance / vehicle gate</p>	<p>Low</p>	<p>6</p>
<p>Gates - Pedestrian</p> <p>Risk Score : 3 Risk Level : Very Low</p>	<p>Entrance</p>	<p>Finding : Gate - Self-Closing - Adjustment</p>

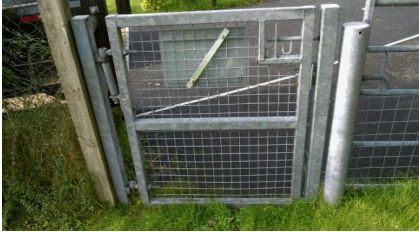
<p>Task : Adjust self-closure mechanism</p>	<p>Low</p>	
<p>Gates - Pedestrian</p> <p>Risk Score : 3 Risk Level : Very Low</p>	<p>Entrance</p>	<p>Finding : Entrapment on side(s) of gate</p>

<p>Notes : Upper gate.</p>	<p>Low</p>

<p>Task : Adjust gate/posts/fit new rubber buffer to ensure a spacing of at least 12mm throughout the range of the gate to remove the entrapment. The 12 mm gap also should apply on the hinge side of the gate</p> <p>Finding : Gate - Buffer(s) required</p>

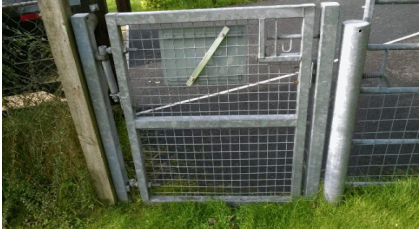
<p>Notes : Lower gate.</p>

<p>Task : Fit buffer(s) to gate</p>	<p>Low</p>	
<b>Site</b>				
<p>Signs - Info</p> <p>Risk Score : 3 Risk Level : Very Low</p>	<p>Signage</p>	<p>Satisfactory</p>

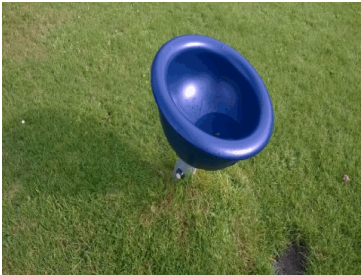
**Carousel - Spinning Cup**

Comments, action or control required	Risk Level	Risk Score ‡
<b>Equipment</b> No remedial maintenance work is required at this time.		
<b>Surfacing - Grass</b>		
Finding : Surface - Worn  Notes : Consider matting wear pad around item.  Task : Replace surface	Low	7
<b>The overall risk for this item at the time of inspection:</b> ‡ For Risk Score see Report Notes	Low	7

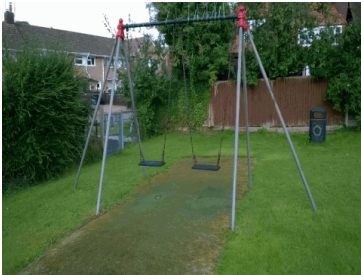
**Swing - Junior - 1 Bay 2 Seat**

The item fails to meet the requirement of the relevant standard.

Comments, action or control required		Risk Level	Risk Score ‡
<b>Equipment</b>			
Finding :	Dry bearings	Low	4
Task :	Treat with oil, grease or silicon spray according to supplier's instructions		
Finding :	The distance between the seat side and the support is insufficient	Low	6
Task :	Monitor and check on a routine basis		
<b>Surfacing - Carpet</b>			
Finding :	Zones Free space Routes	Low

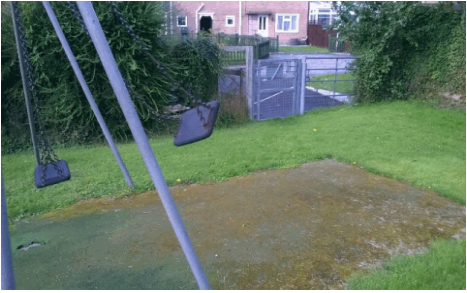
Finding : <b>Surface - Holes</b>	Medium	8
Notes : <b>Under seats.</b>

Task : <b>Repair surface</b>		
<b>The overall risk for this item at the time of inspection:</b> ‡ For Risk Score see Report Notes	Medium	8

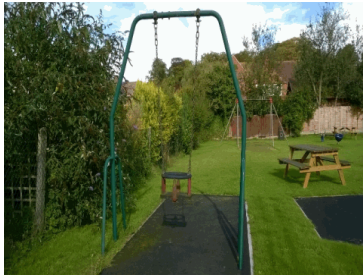
**Swing - Toddler - 1 Bay 1 Seat**

Comments, action or control required	Risk Level	Risk Score ‡
<b>Equipment</b>		
Finding : Dry bearings	Low	5
Task : Treat with oil, grease or silicon spray according to supplier's instructions		
Finding : Item - Cap missing	Low	4
Notes : Bolt on top frame.		
Task : Replace item		
<b>Surfacing - Wet Pour</b>		
Finding : Surface - Grass, Moss or Weeds	Low	6
Finding Date : 15/09/2017		
Task : Remove grass, moss & weeds from playing surface		
Finding : Surface - Edges Shrunken	Low	5
Task : No action given the risk assessment		
<b>The overall risk for this item at the time of inspection:</b>	Low	6
‡ For Risk Score see Report Notes
