# PLAY AREA SAFETY INSPECTION REPORT

Winterbourne Stoke Parish Council

15 September 2017

Site Owner : **Winterbourne Stoke Parish Council**  
Site Name : Winterbourne Stoke PC - St. Peters Close  
Date of Inspection : 15 September 2017  
Inspected by : Peter Mann

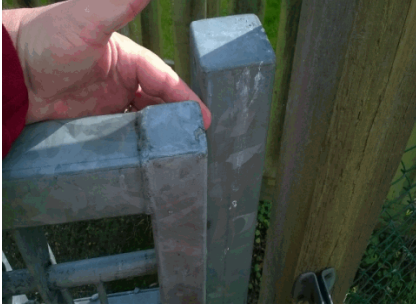
<p>Gates - Pedestrian</p> <p>Risk Score : 3 Risk Level : Very Low</p>	<p>Entrance</p>

<p>Task : Adjust gate/posts/fit new rubber buffer to ensure a spacing of at least 12mm throughout the range of the gate to remove the entrapment. The 12 mm gap also should apply on the hinge side of the gate</p> <p>Finding : Gate - Buffer(s) required</p>

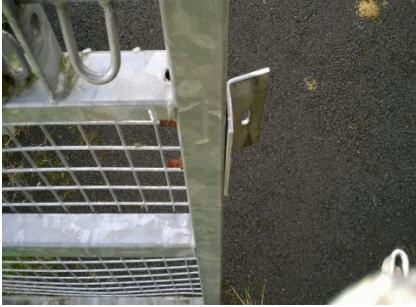
<p>Notes : Lower gate.</p>

<p>Task : Fit buffer(s) to gate</p>	<p>Low</p>	
<b>Site</b>				
<p>Signs - Info</p> <p>Risk Score : 3 Risk Level : Very Low</p>	<p>Signage</p>	<p>Satisfactory</p>

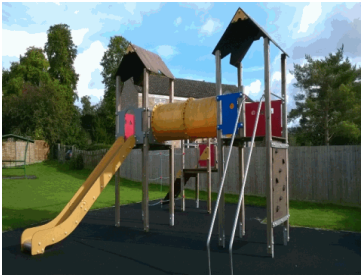
**Multiplay - 3 Towers**

Risk Level : Low

Risk Score : 6

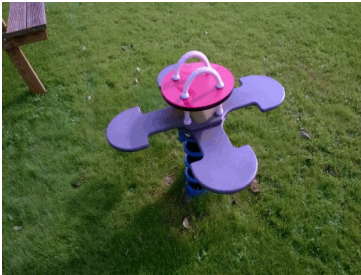
**Rocker - 4 Seat**

Risk Level : Low

Risk Score : 4
